Network of Standby Oil Spill Response Vessels

# Drills and Exercises Annual Report 2015

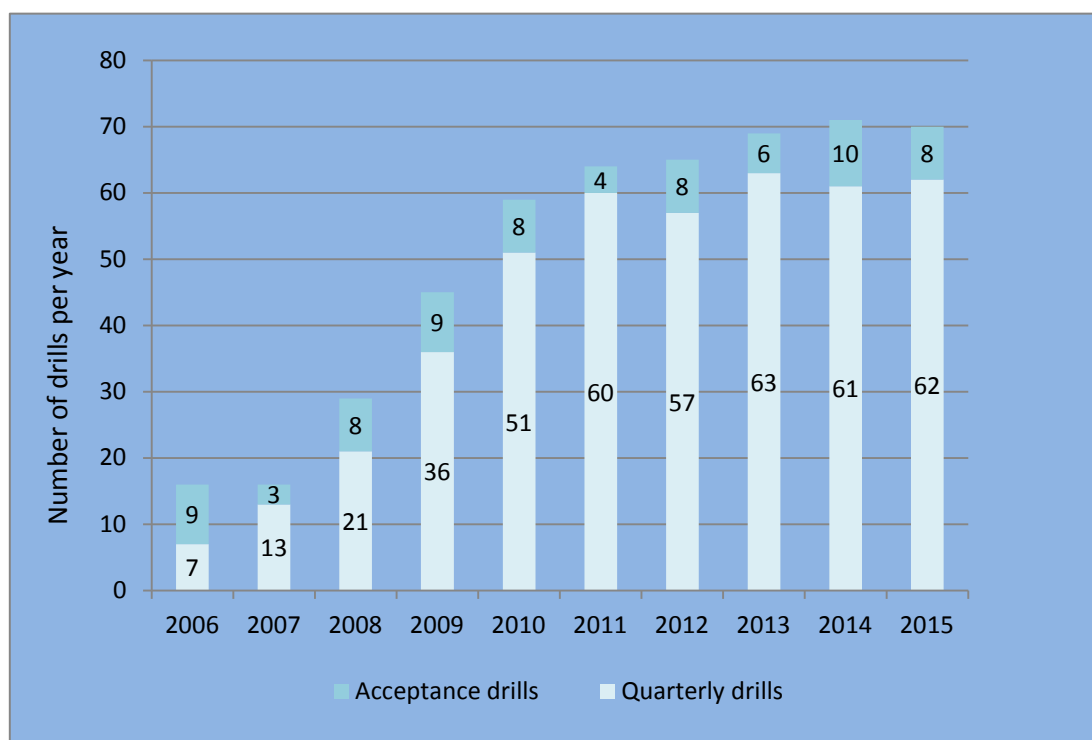
Chart 1. Number of drills 2006-2015

Over recent years the Network has been maintained at its maximum planned size, and the number of drills and exercises occurring each year has remained relatively stable. A summary of drills performed by EMSA contracted vessels during the period 2006-2015 is shown in the chart below.

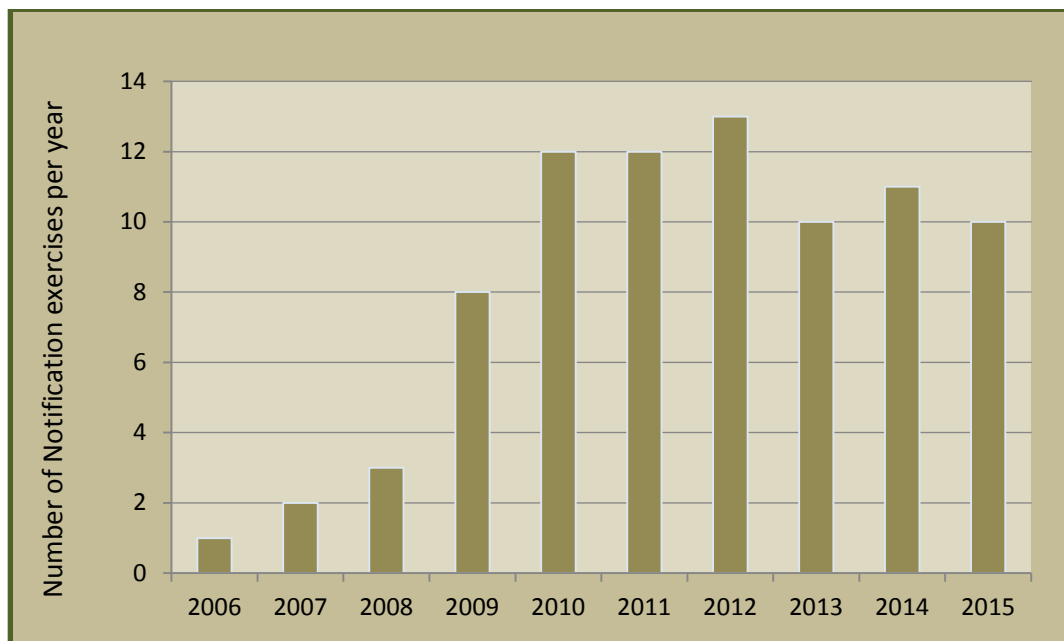
**Chart 2. Number of notification exercises 2006 – 2015**

The number of notification exercises carried annually over the years 2006-2014 is shown on the chart below.

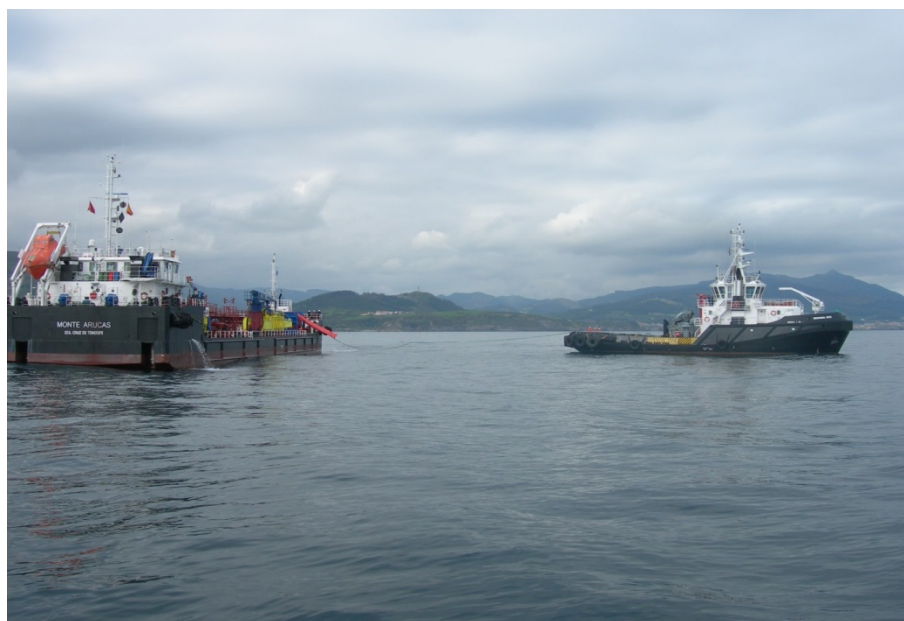
Fig.1. *Monte Arucas* and *Ibaizabal 11* deploying the boom

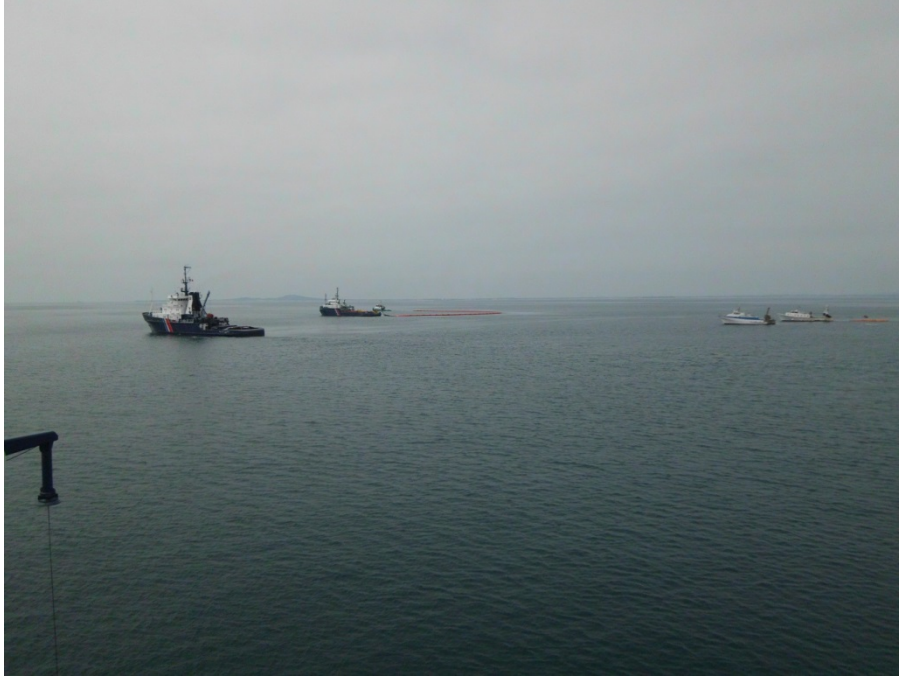
Fig.3. POLMAR MER 2015 - French vessels exercising oil recovery seen from the deck of the *Brezzamare*

The *Brezzamare* performed well. The vessel found the oil slick using the on board slick detection system. Oil was successfully recovered by means of sweeping arm system. *Brezzamare* fulfilled the role assigned by the exercise commander and also met the expectations of the Agency.

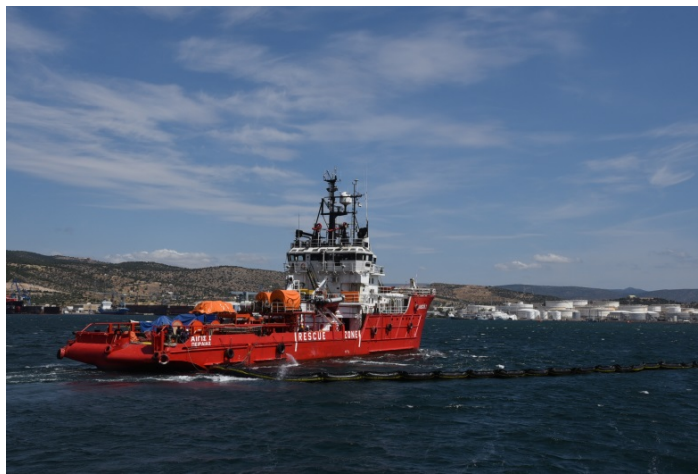
Fig.6. *Aegis I* towing the boom in J formation

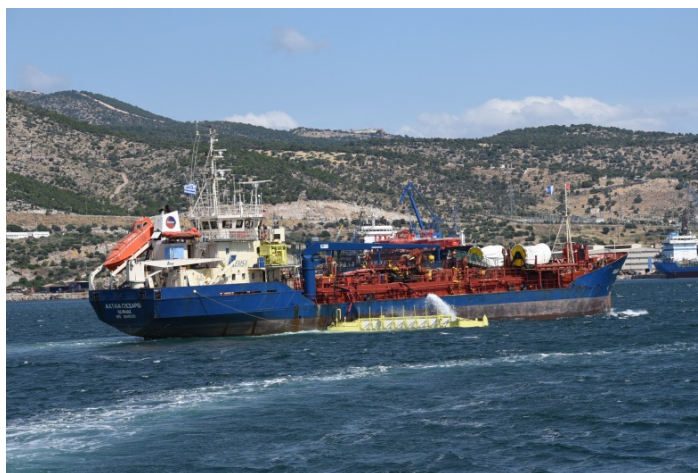
Fig.7. *Aktea OSRV* collecting oil with sweeping arm system
